PALLET RACK ASSESSMENT

SAMPLE REPORT • CUSTOMER DETAILS REMOVED

Sample Customer, Inc.
Distribution Center
Anytown, USA

Axiom, Inc.
Rack Inspection Services

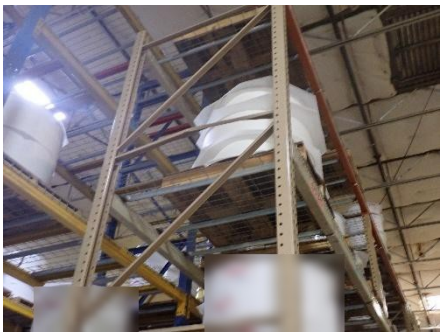
OBSERVATION #:	7	LOCATION:	Exact Racking - Upright SC1AA (REPEAT)

OBSERVATION DESCRIPTION:	The 1st and 3rd-level horizontal braces are bent.				
CORRECTIVE ACTION:	Reference the rack manufacturer's specifications to determine if the brace can be repaired or if the upright needs to be replaced. All repairs and parts shall meet the manufacturer's specifications. If repair or replacement is not required, monitor for further worsening conditions.				
CHAMPION:		**TARGET DATE:**		**COMPLETION DATE:**

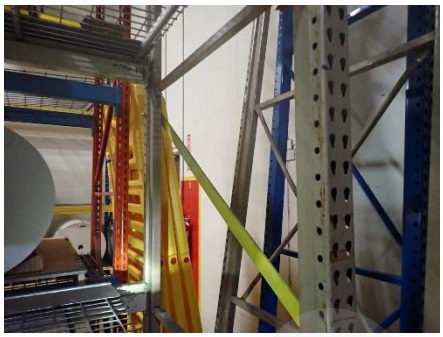
OBSERVATION #:	16	LOCATION:	Exact Racking - Upright SC11CB (REPEAT)

OBSERVATION DESCRIPTION:	Only one of the diagonal braces was repaired. It appears the repairs are not in accordance with the manufacturer's specifications.		
CORRECTIVE ACTION:	Reference the rack manufacturer's specifications to determine if the braces can be repaired or if the upright needs to be replaced. All repairs and parts shall meet the manufacturer's specifications. If repair or replacement is not required, monitor for further worsening conditions.		
CHAMPION:		**TARGET DATE:**	
		COMPLETION DATE:
